# Manhole Inspection Summary

Manhole # S53O\_\_017MH

Insp Date: **4/17/08 10:00 AM**

**Location** Address: **1205 south elwood avenue**

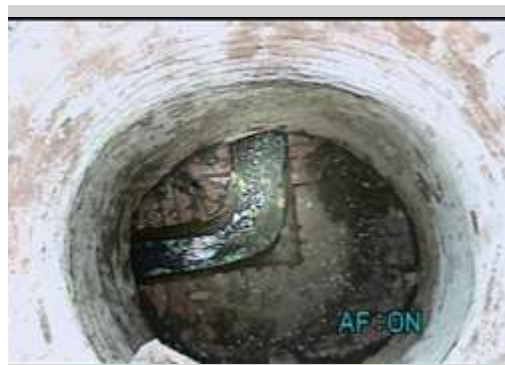
Top View

**Inspection** ☐ Is Incomplete Rating: **3) Fair**

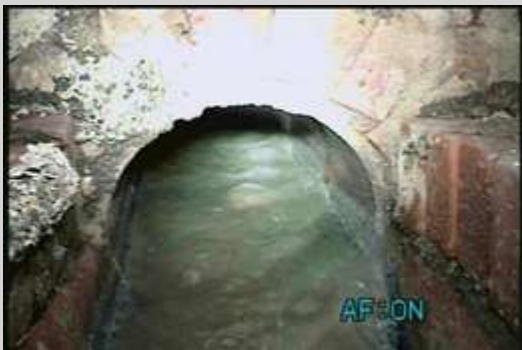
12 O'Clock Outflow

8 in. Circular Gravity Sewer  
Pipe Out @ 12 O'Clock

Pipe Material: **Clay** ☐ Pipe Lined

Invert Depth: **8.60** (ft.) Flow Characteristics: **Fast**

Deposits: ☒ None ☐ Mud ☐ Sludge ☐ Debris ☐ Grease

Infiltration: **None** Pipe Seal Cond: **Unknown**

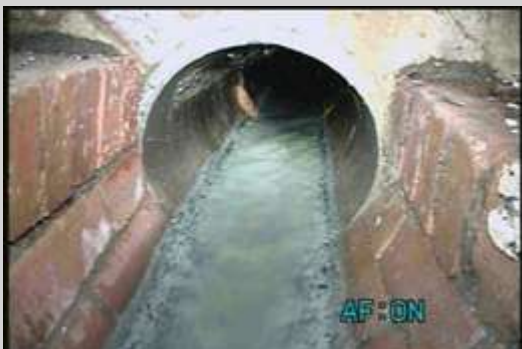
9 O'Clock Inflow

10 in. Circular Gravity Sewer  
Pipe In @ 9 O'Clock

Pipe Material: **Clay** ☐ Pipe Lined

Invert Depth: **8.30** (ft.) Flow Characteristics: **Fast**

Deposits: ☒ None ☐ Mud ☐ Sludge ☐ Debris ☐ Grease

Infiltration: **None** Pipe Seal Cond: **Unknown**
